PROJECT: Midnite Mine Remediation

REPORT NO: 2019-013

This weekly report provides a summary of Midnite Mine Site (Site) remediation action (RA) construction activities, quality assurance (CQA), quality control (CQC) and engineering activities for the period June 21 – June 27, 2019. The Site activities discussed in this weekly report include, but are not limited to: Site Health, Safety, and Security; Community Liaison, Project Meetings, Regulatory Oversight, Site Visitors; Site Mobilization; RA Activities; Project Documentation; and Site Inspections.

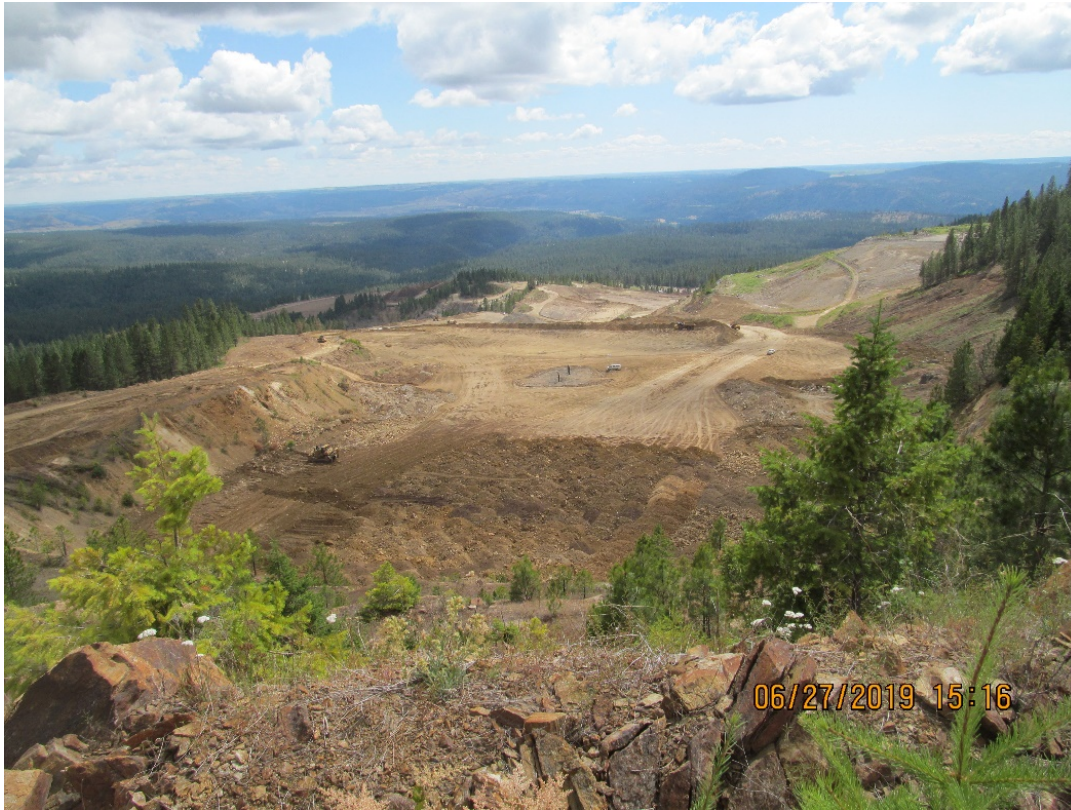
Figure 1 – Overview of Pit 4, looking south

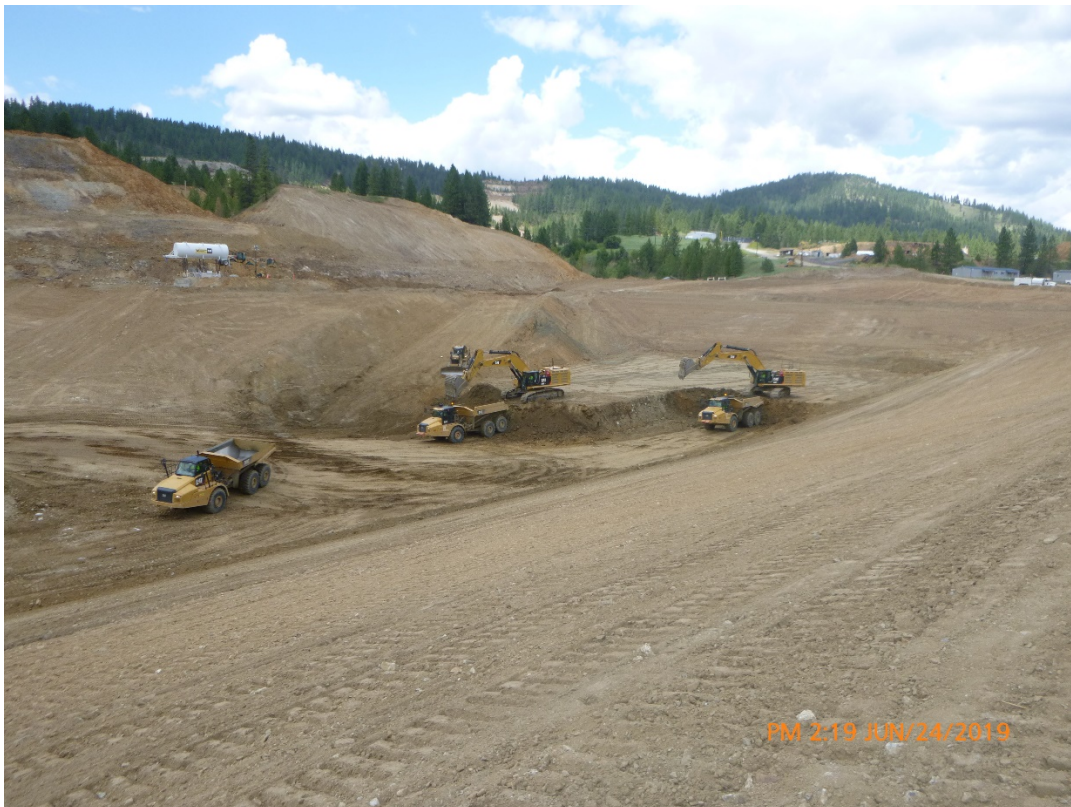
Figure 2 – 390 Excavators loading material from the South Pond excavation.

- Pit 4 Backfill
 - Excavation of mine waste from the South Pond Cut/SWRP (low reactivity/low activity material) was used to construct the 20-foot buffer zone (rind), or was placed as general fill in the south bench area and in the northern portion of the pit.

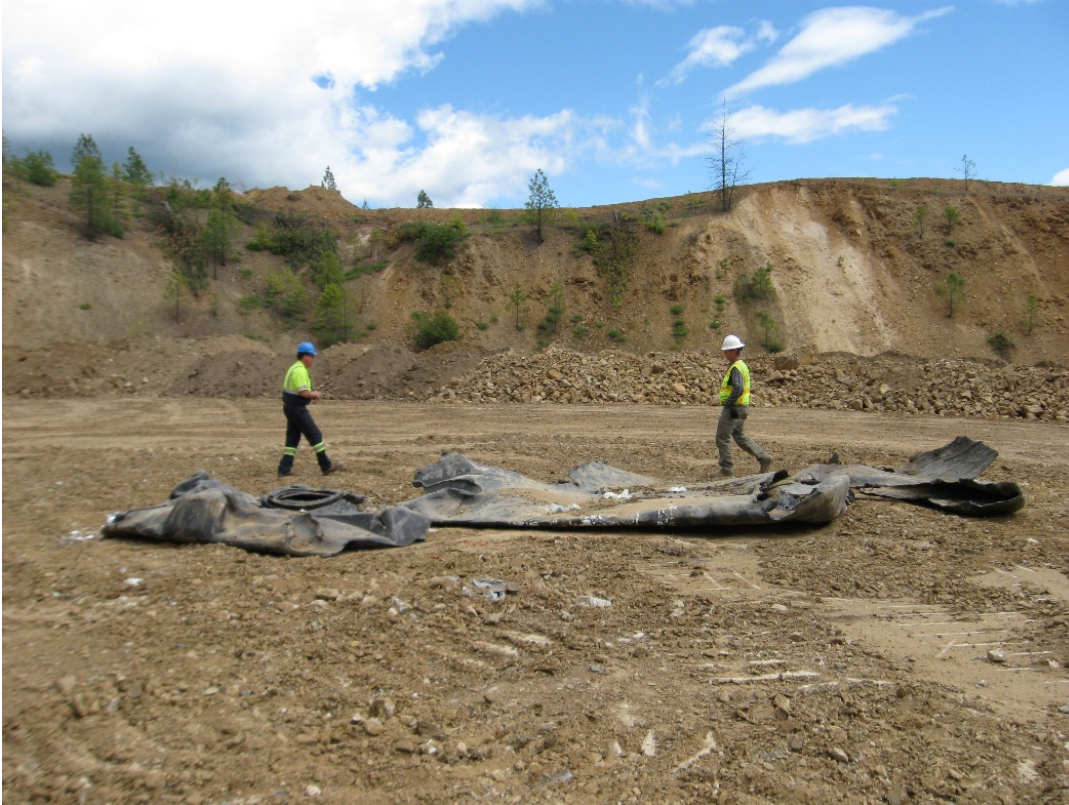
Figure 3 – Crushed ligno tank, looking east

- 6/21/2019 – The D9 dozer crushed the failed ligno tank to a height of ≤ 2 feet and was buried in the northern portion of the pit within the Demolition Debris Zone.

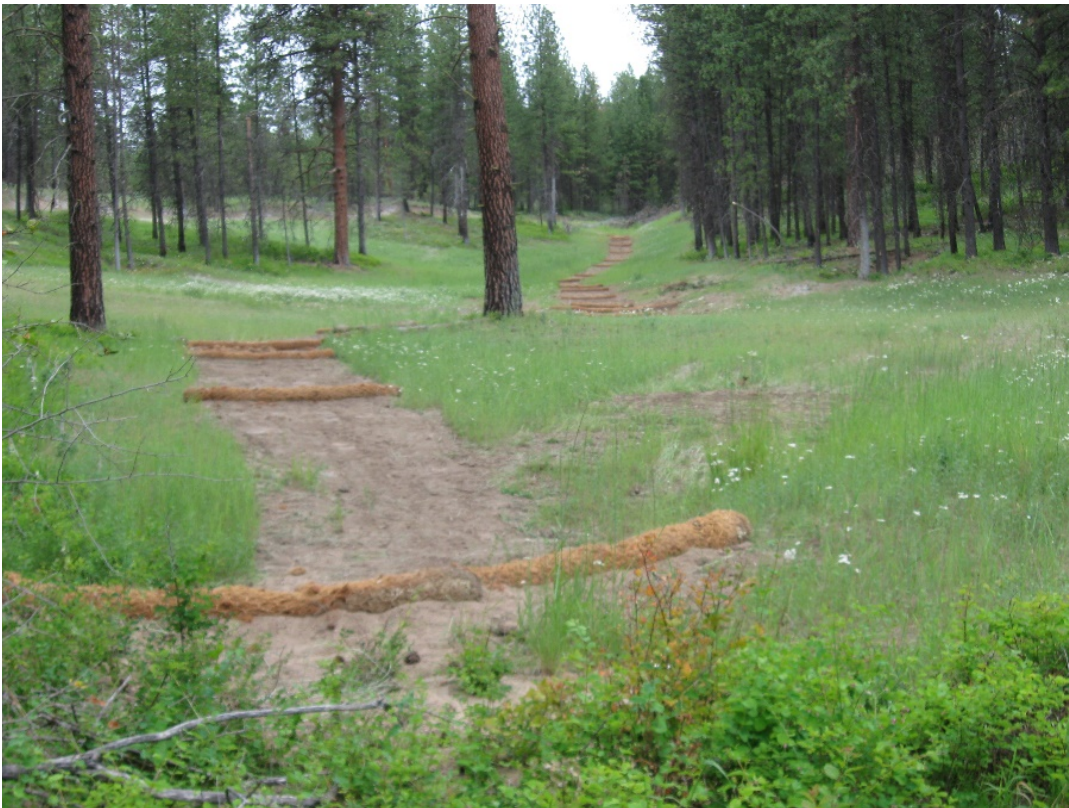
Figure 4 – West Access Road main drainage following SWPPP repairs

- The main drainage area was regraded, two new sed ponds were constructed (one on each side of the road where the drainage crosses) and check dams/wattles were installed along the length of the drainage.
